CAPITAL IMPROVEMENT &  
PROTECTION PLAN

# CITY OF TAMPA PARKING STRUCTURES

TAMPA, FLORIDA

PROJECT # 15-1340.40

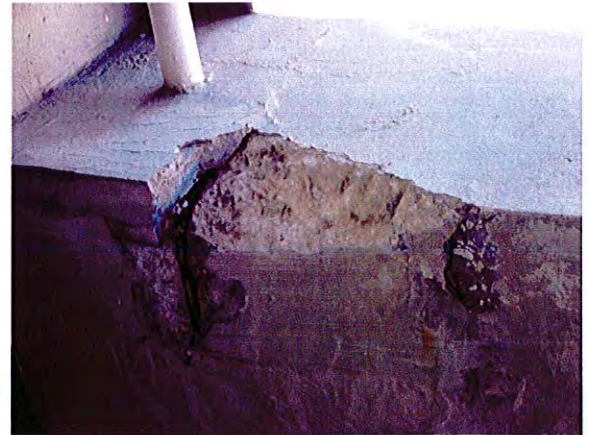
**CONCRETE SURFACE DETERIORATION**

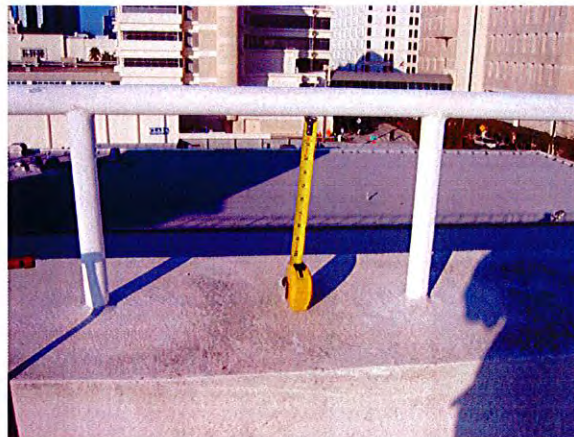
**PERIMETER BEAM DETERIORATION**

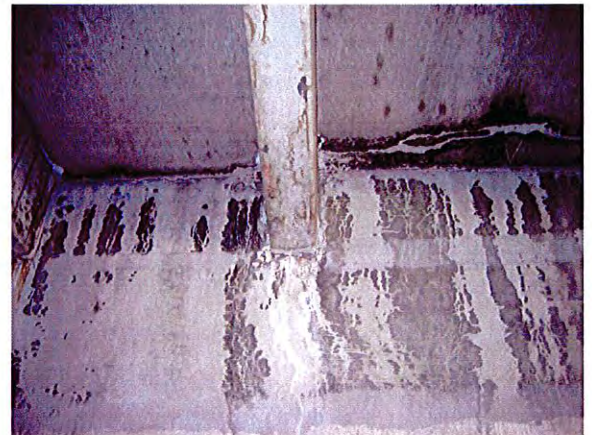
**THROUGH-SLAB LEAKAGE**

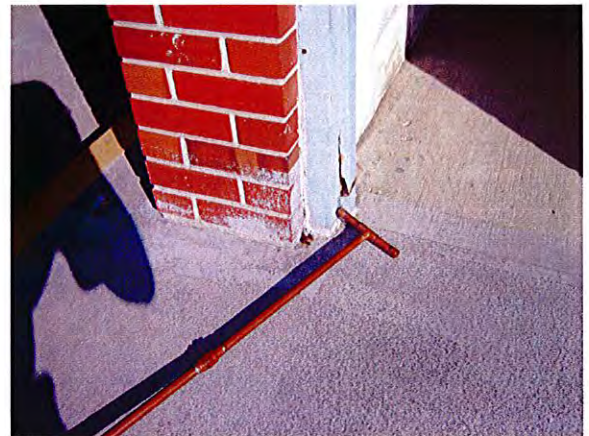
EXPANSION JOINT NOSING DETERIORATION

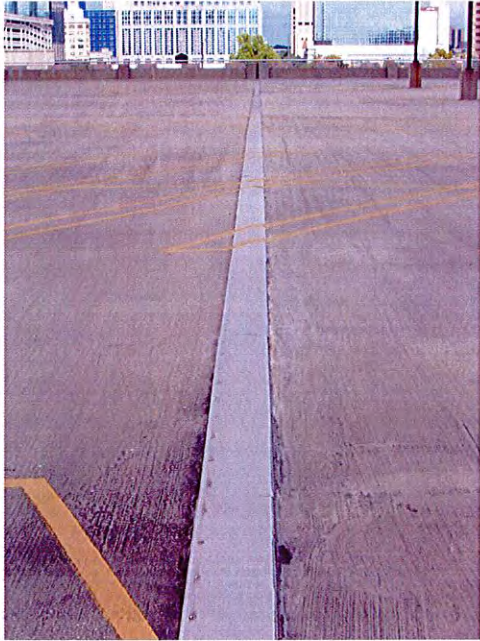
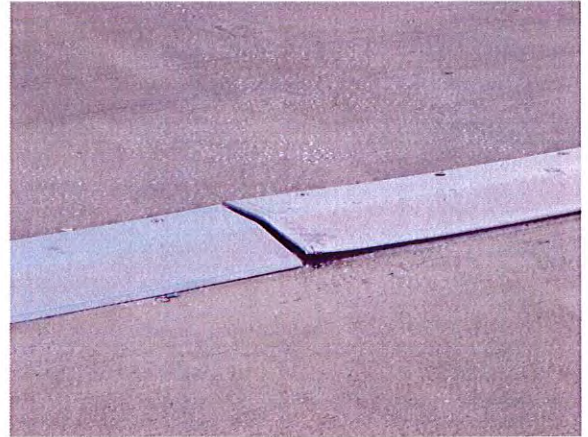
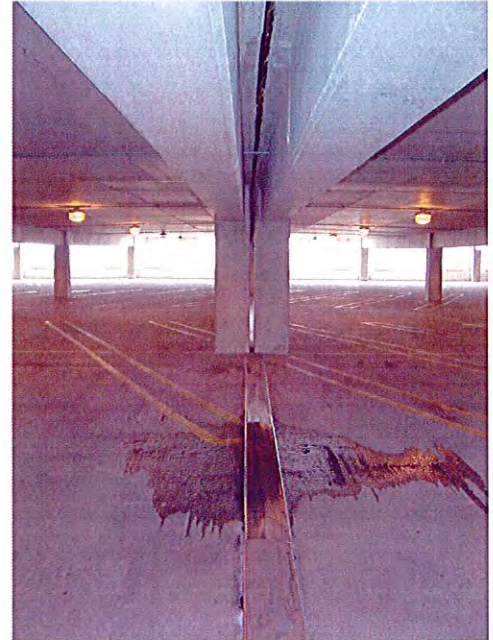
**JOINT COVER DAMAGE AND LEAKAGE AT EXPANSION JOINTS**

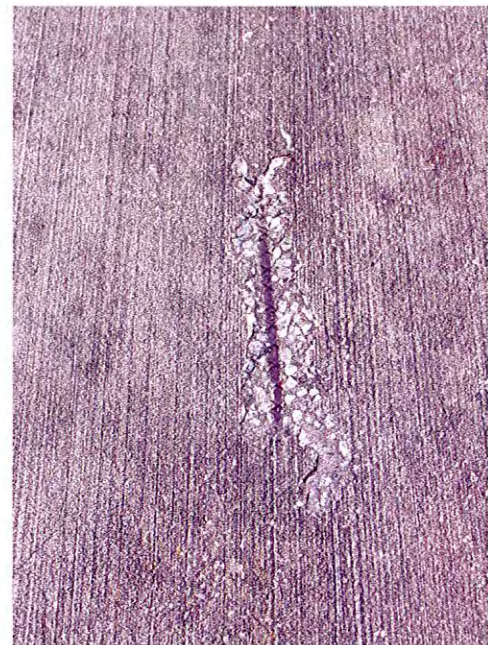
SHALLOW DELAMINATION

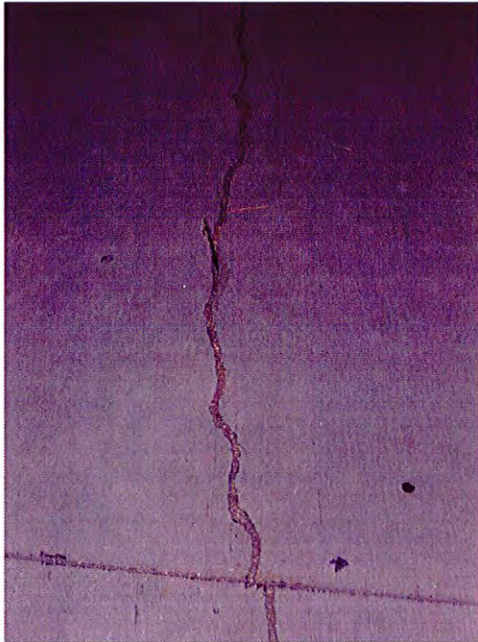
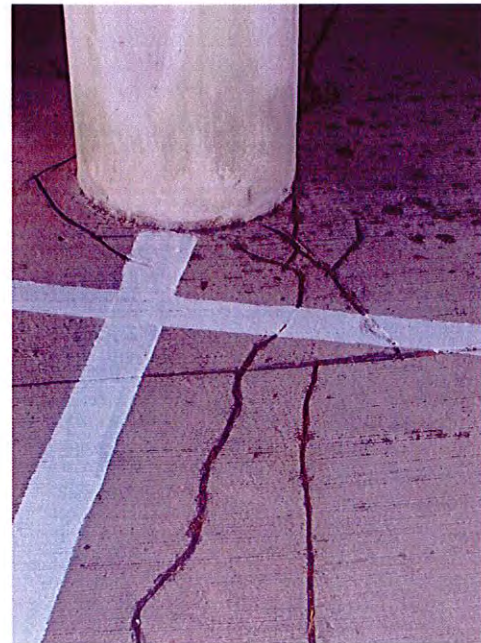
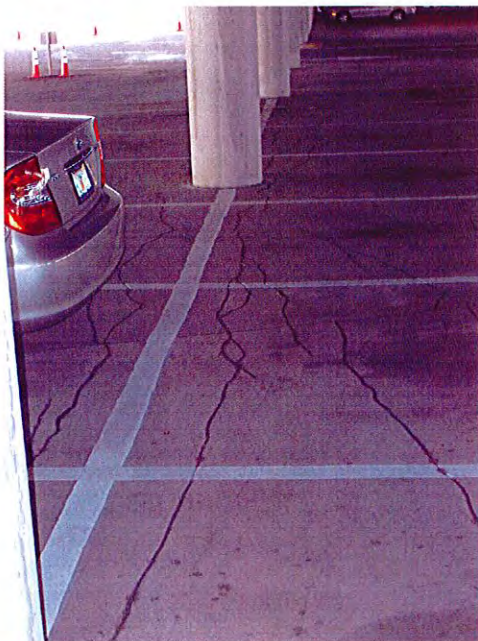
**FLOOR SLAB CRACKING**

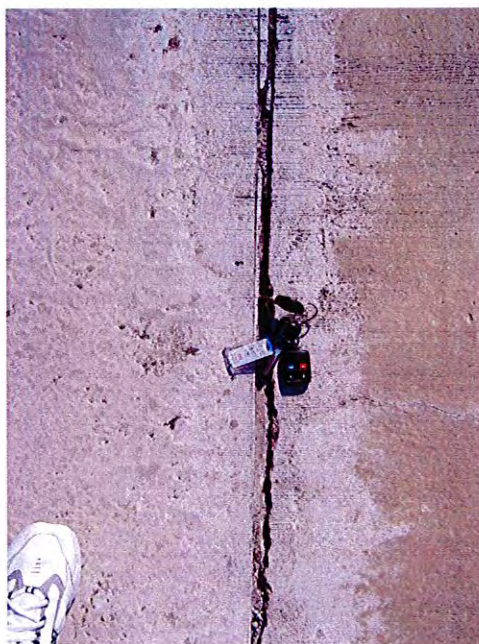
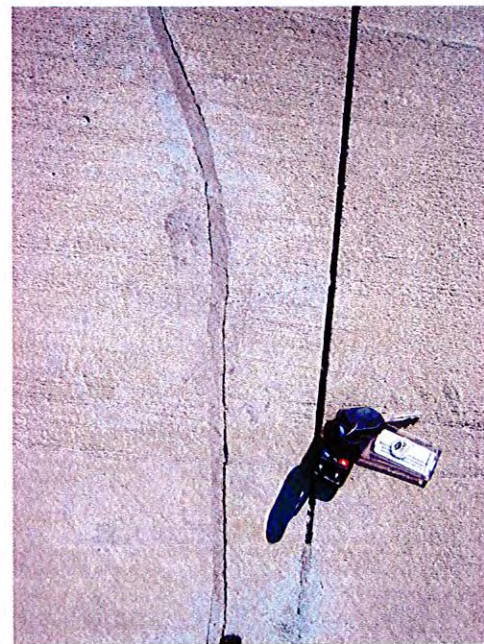
**FAILED SEALANT AT FLOOR CRACKS AND JOINTS**

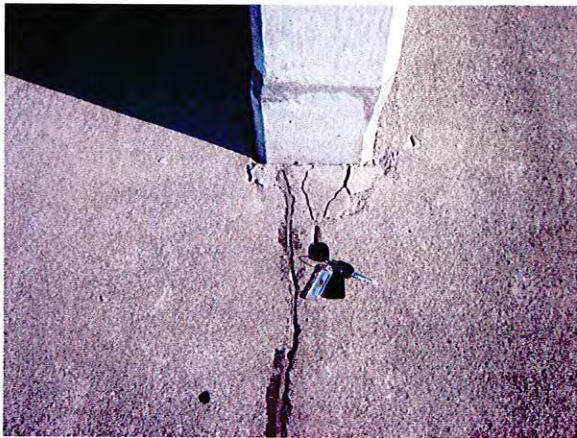
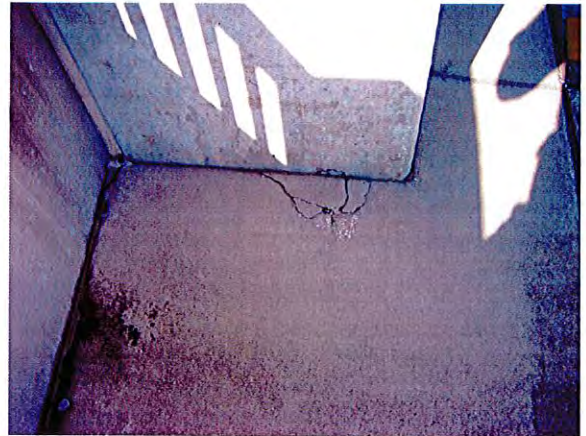
**SPALLED FLOOR SLAB CONNECTIONS AT COLUMNS  
AND SHEAR WALLS**

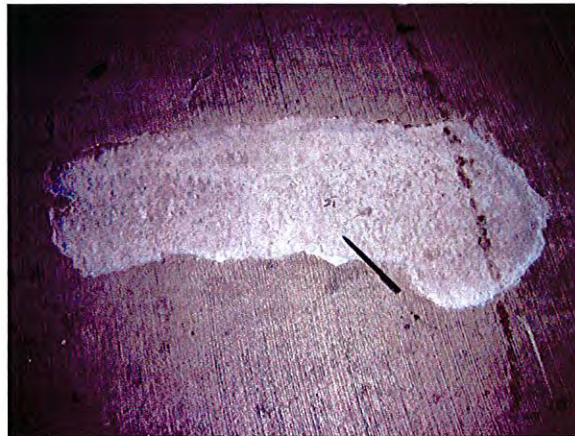
**MINOR SPALLING AT CONCRETE WALLS AND FLOOR SURFACES**

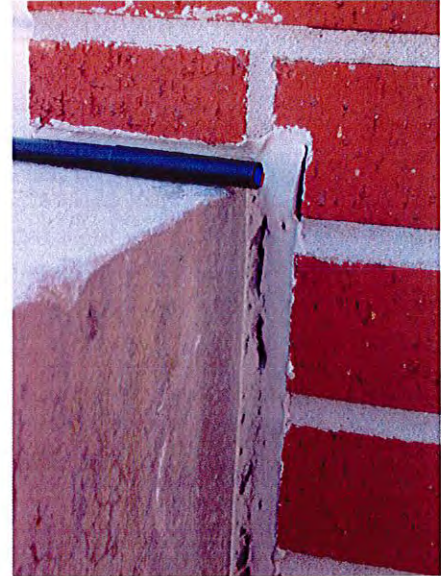
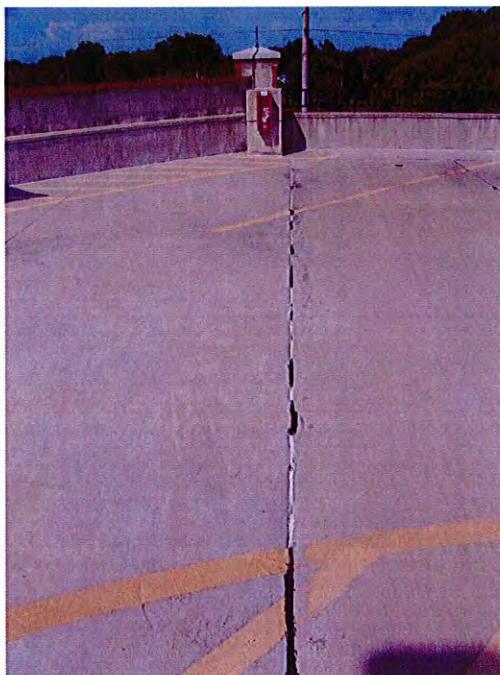
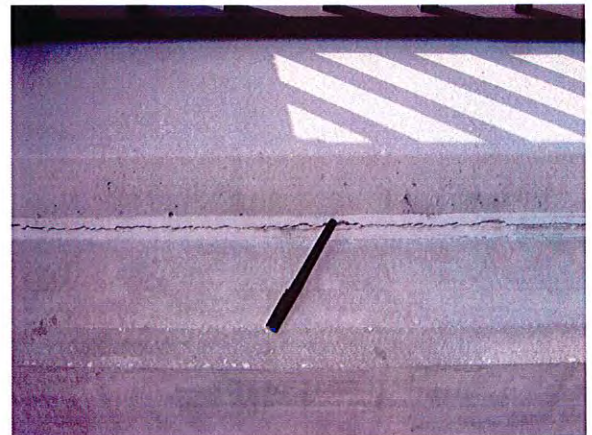
**SEALANT FAILURE AT FACADE JOINTS, FLOORS, AND CURBS**

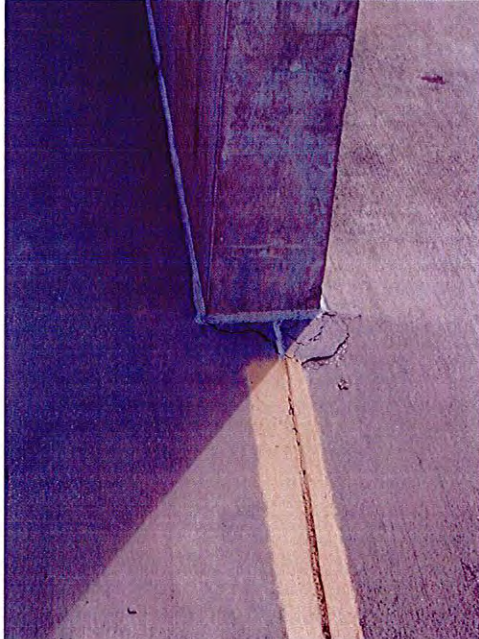
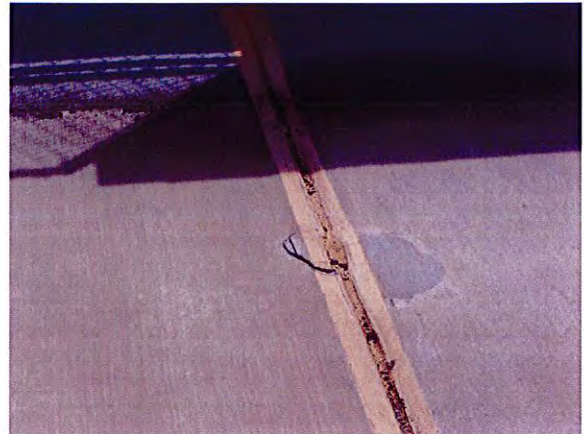
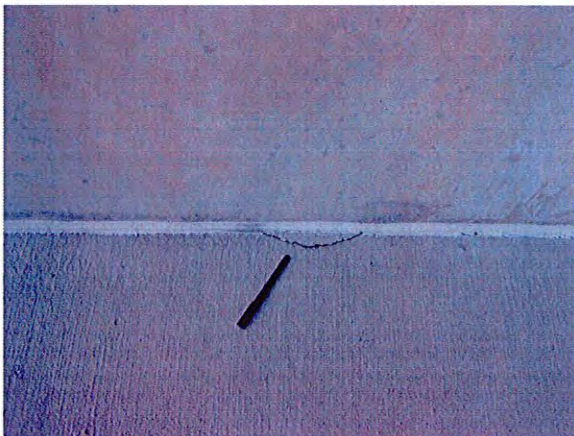
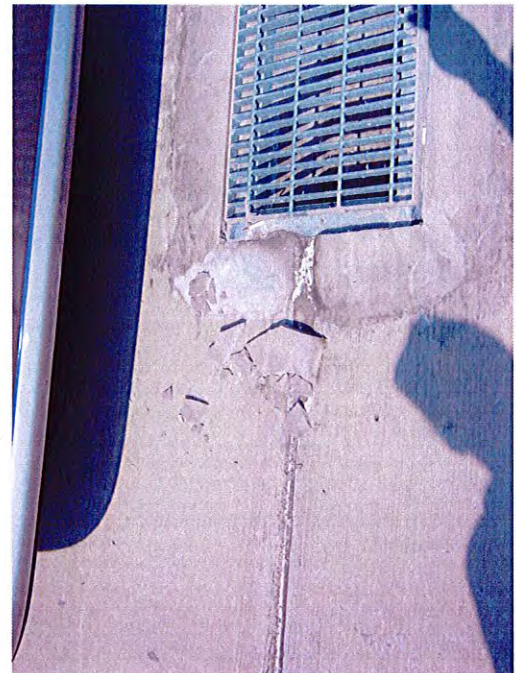
**CONCRETE FLOOR DETERIORATION AT CONNECTIONS**

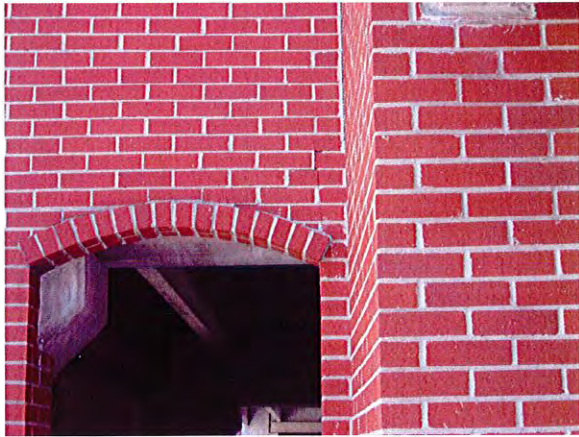
CRACKING @ MORTAR JOINTS

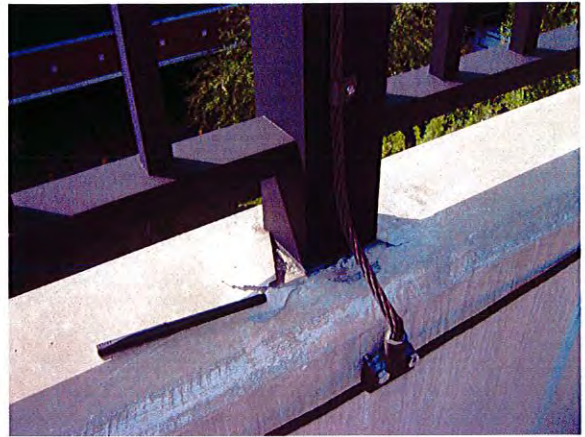
SPALLING @ HANDRAIL SUPPORT

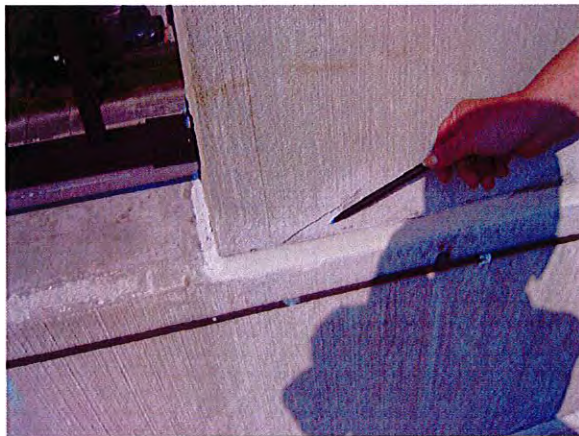
CRACKING @ FAÇADE PANEL

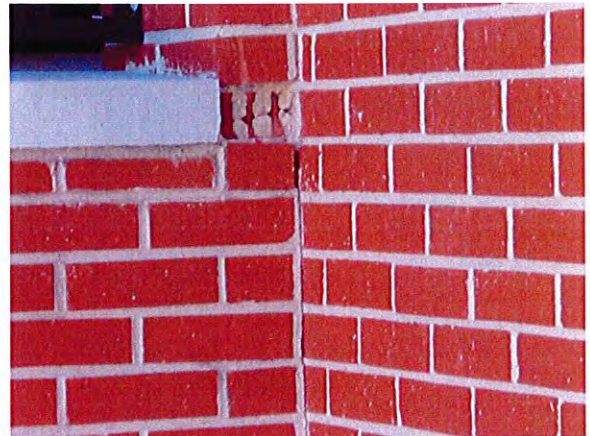
SPALLED BRICK FACE

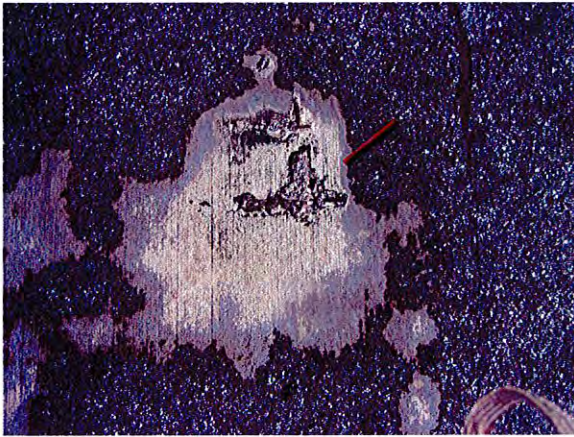
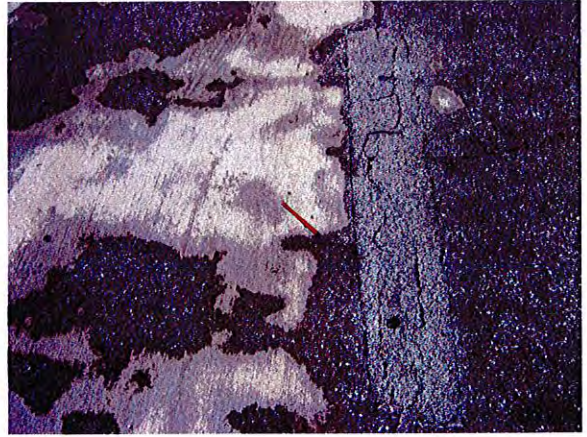
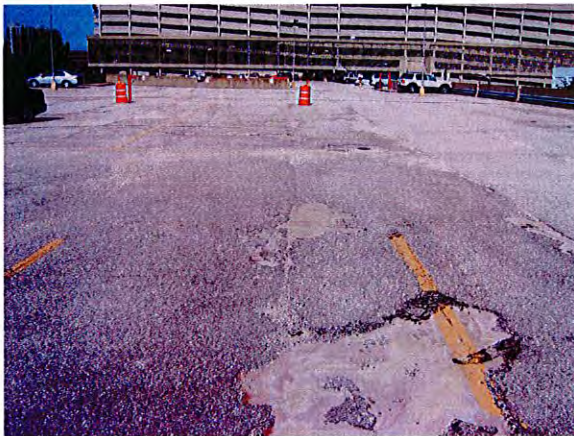
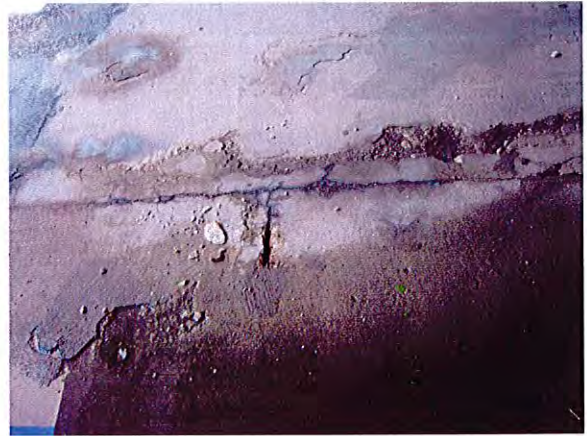
**ROOF LEVEL FLOOR SURFACE DETERIORATION**

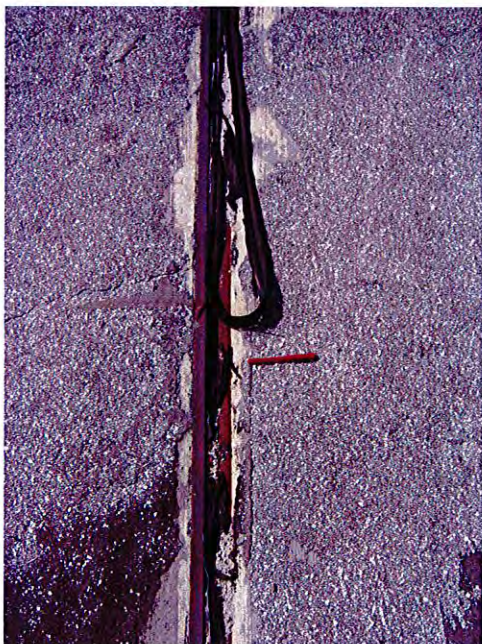
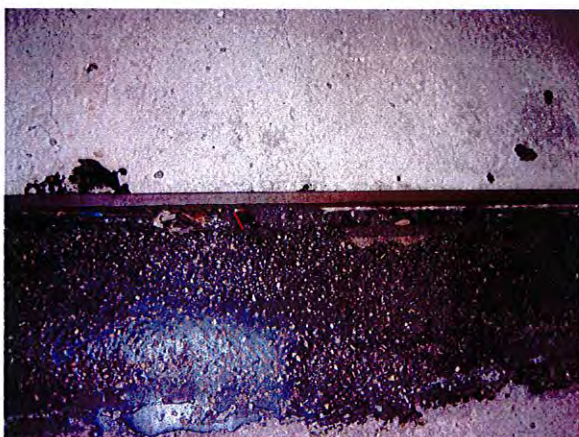
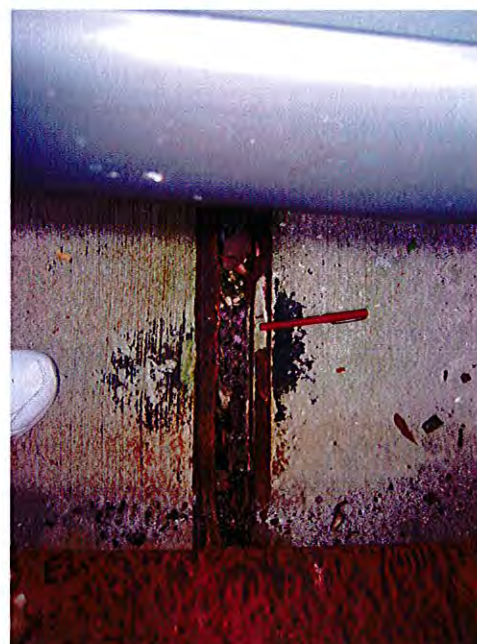
**EXPANSION JOINT DETERIORATION**

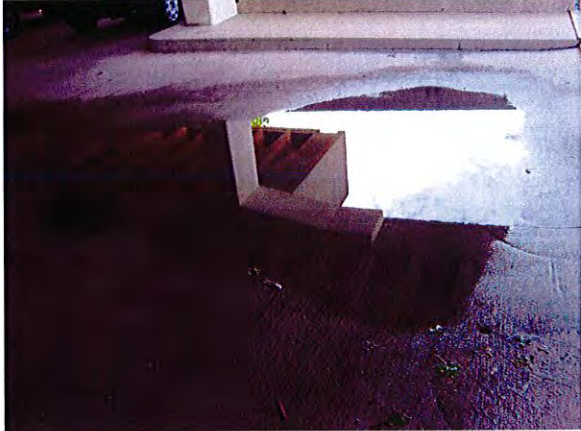
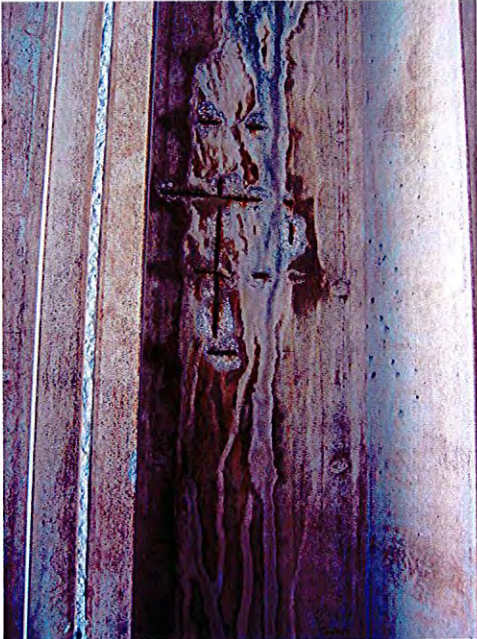
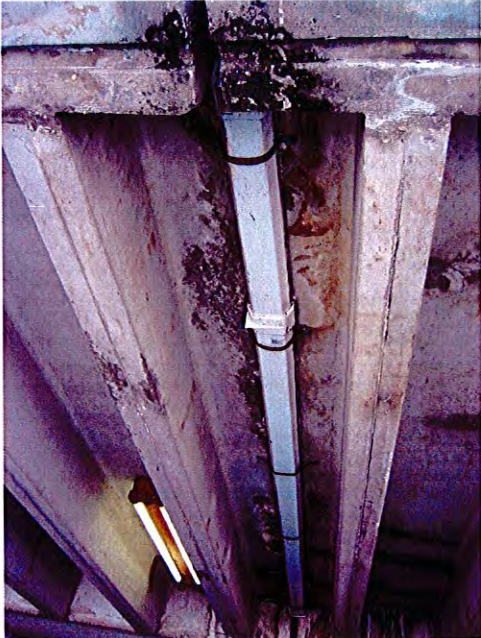
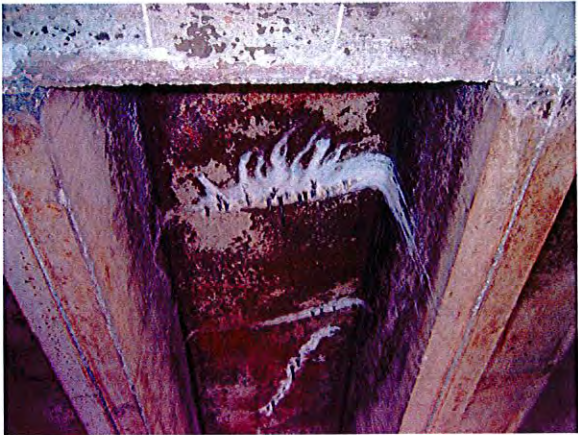
PONDING WATER AND THROUGH-SLAB LEAKS

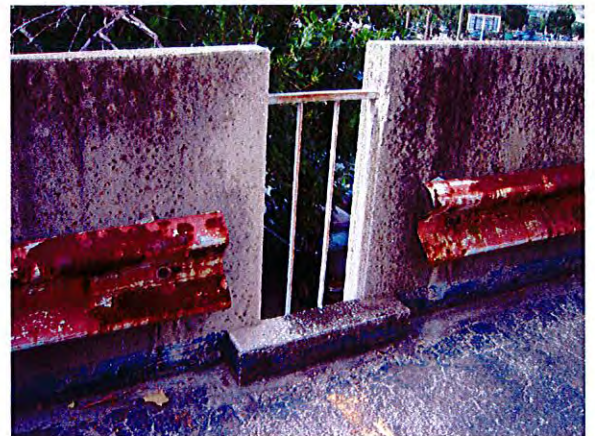
**LOW BARRIER WALL / RAILING CONDITIONS**

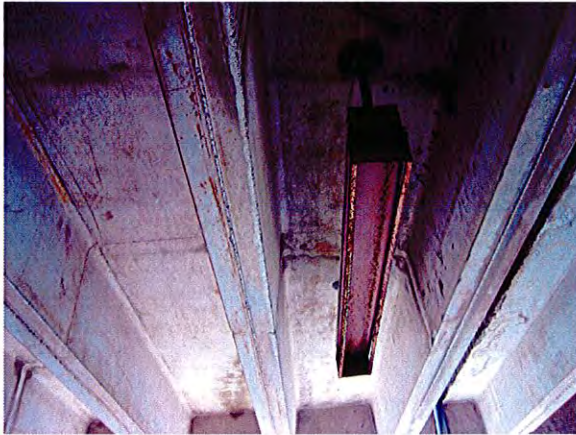
TYPICAL DEFECTIVE LIGHTING FIXTURE

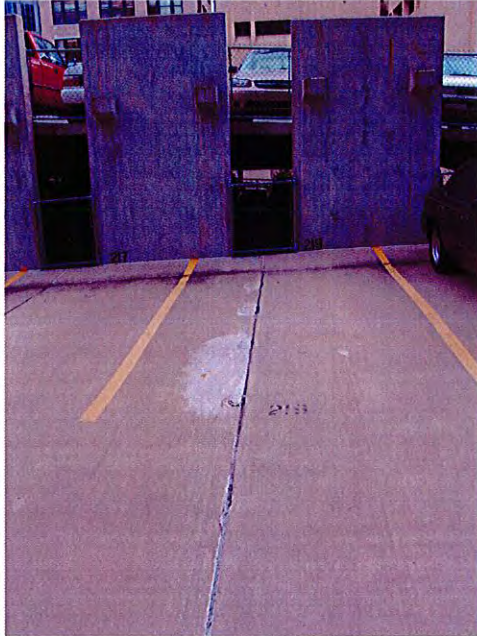
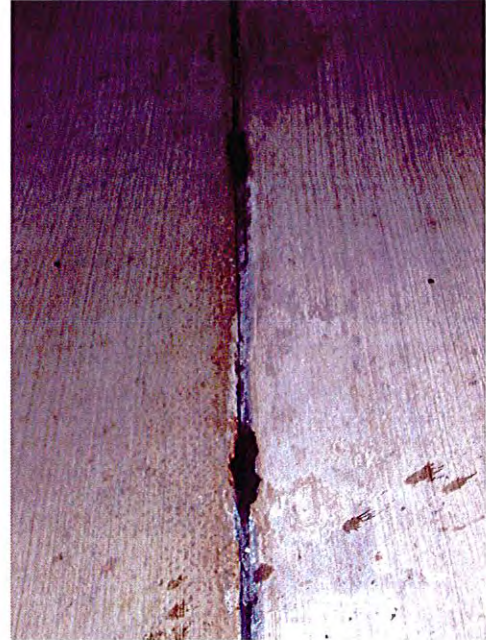
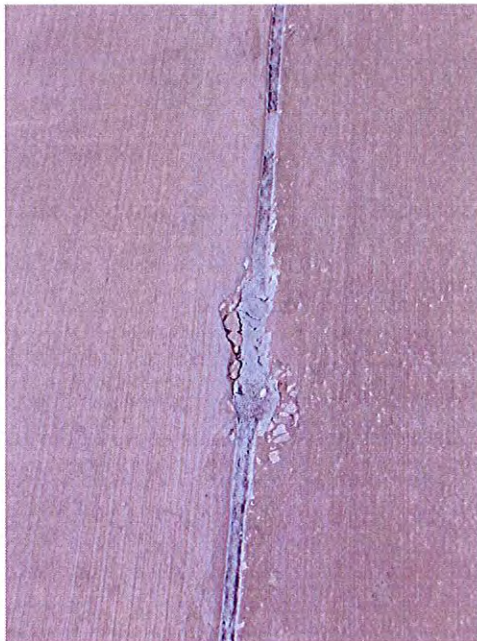
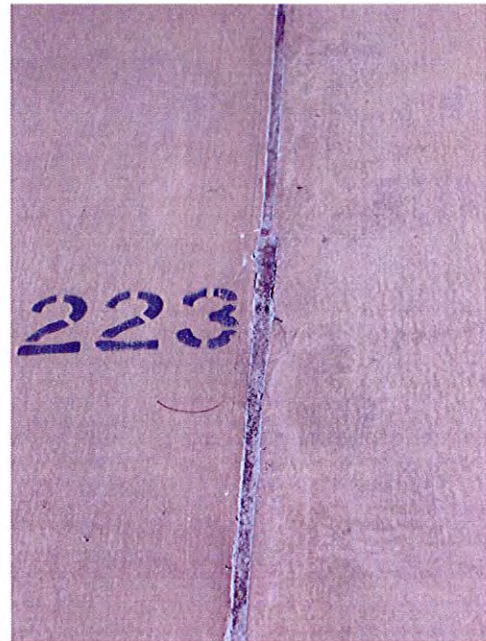
**JOINT EDGE AND SEALANT DETERIORATION**

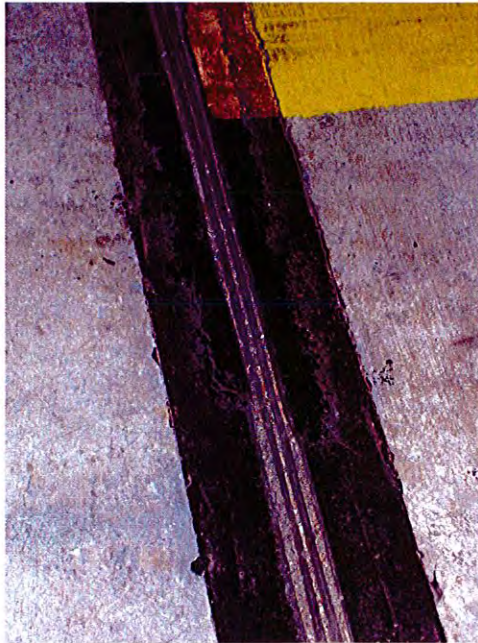
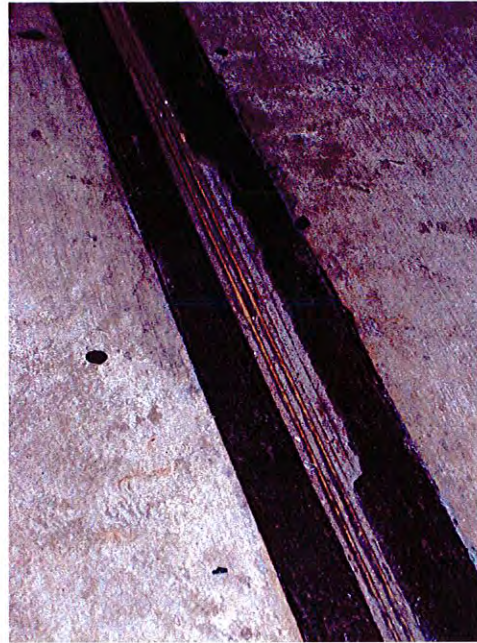
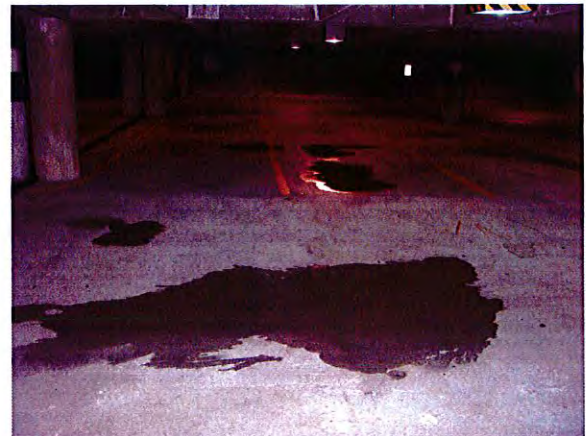
**EXPANSION JOINT DAMAGE AND LEAKAGE**
