CAPITAL IMPROVEMENT &  
PROTECTION PLAN

# CITY OF TAMPA PARKING STRUCTURES

TAMPA, FLORIDA

PROJECT # 15-1340.40

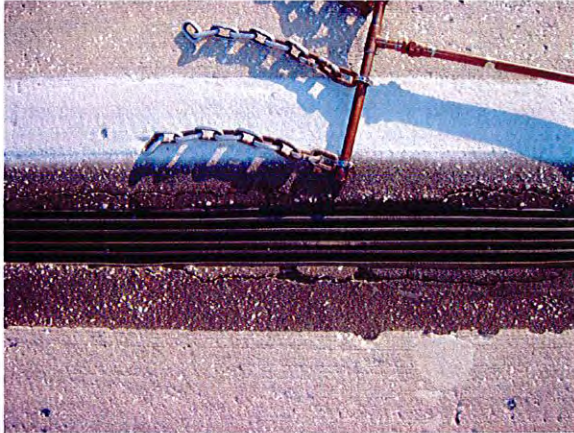
EXPANSION JOINT NOSING DETERIORATION

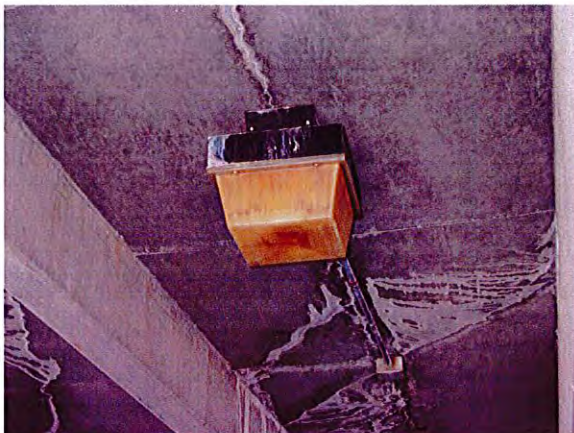
DISCOLORED LIGHT FIXTURE LENS

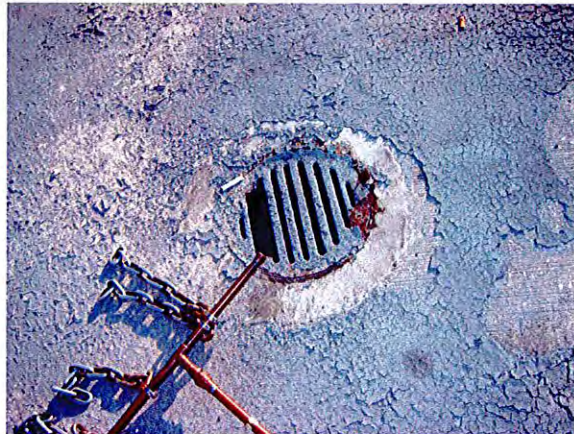
**BROKEN DRAIN GRATE**

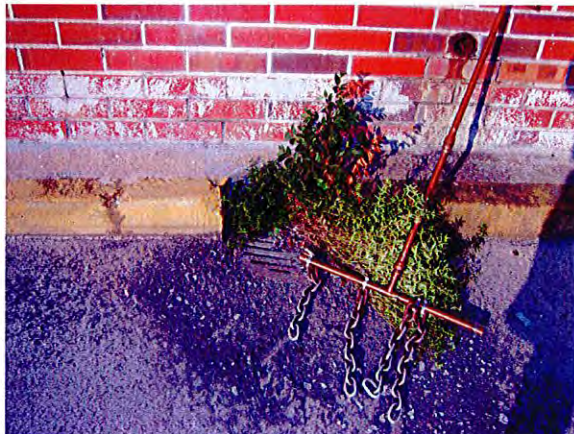
**ACCUMULATED DEBRIS AND VEGETATION**

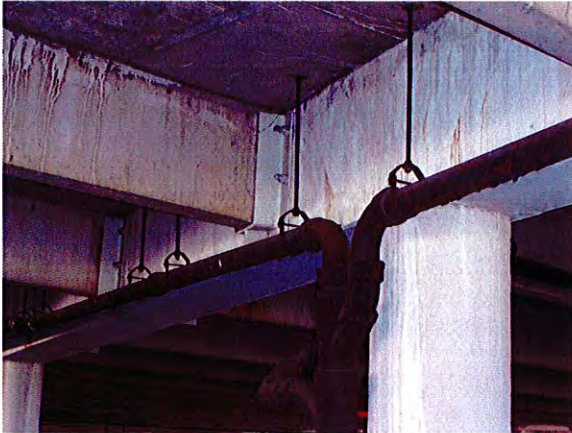
HEAVY CORROSION ON DRAIN PIPING

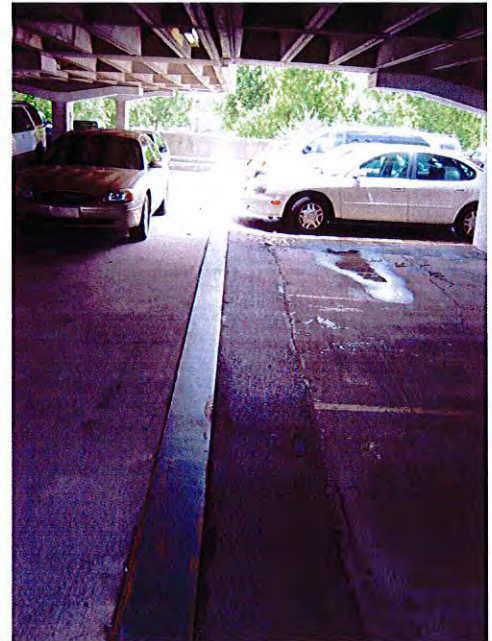
WASH AT EXPANSION JOINT
