CAPITAL IMPROVEMENT &  
PROTECTION PLAN

# CITY OF TAMPA PARKING STRUCTURES

TAMPA, FLORIDA

PROJECT # 15-1340.40

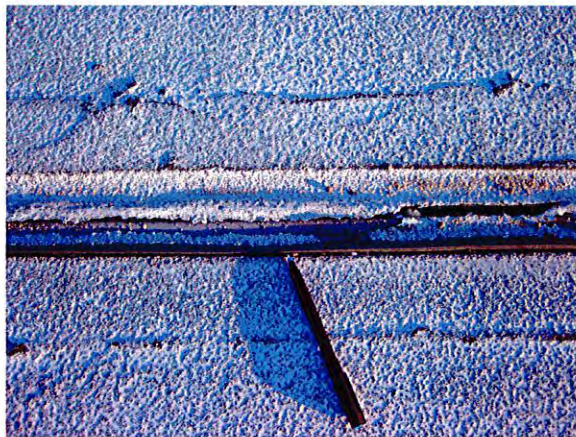
FORT BROOKE GARAGE

**DAMAGED / DETERIORATED EXPANSION JOINTS**

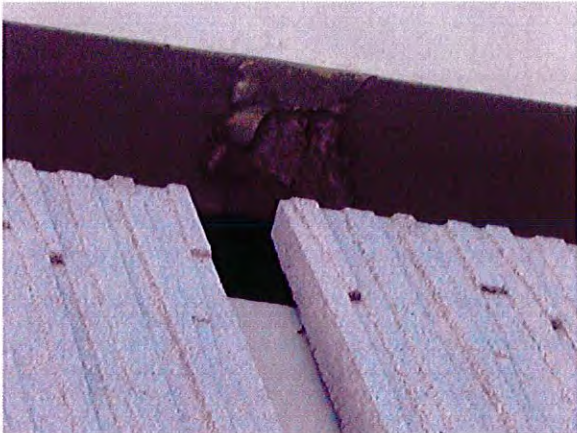
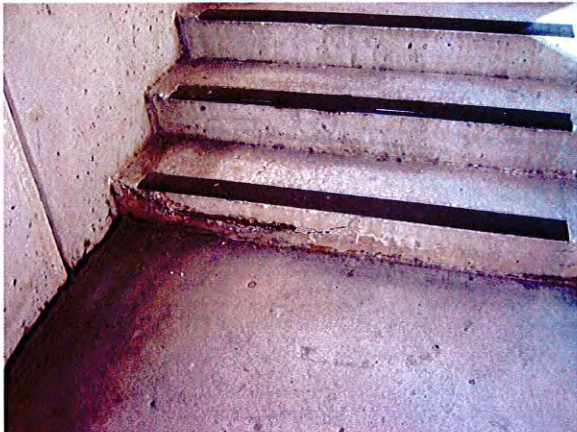
**MISCELLANEOUS CONCRETE DETERIORATION**

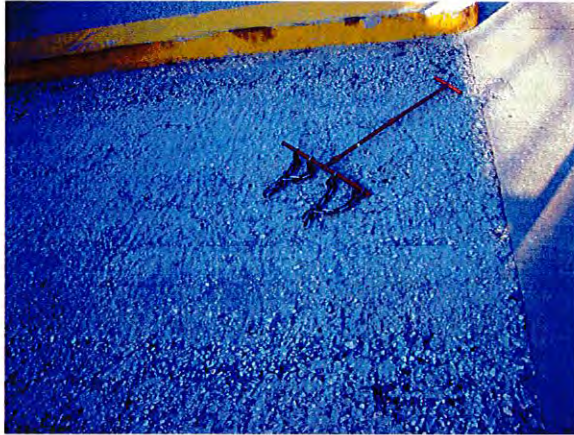
FLOOR SCALING

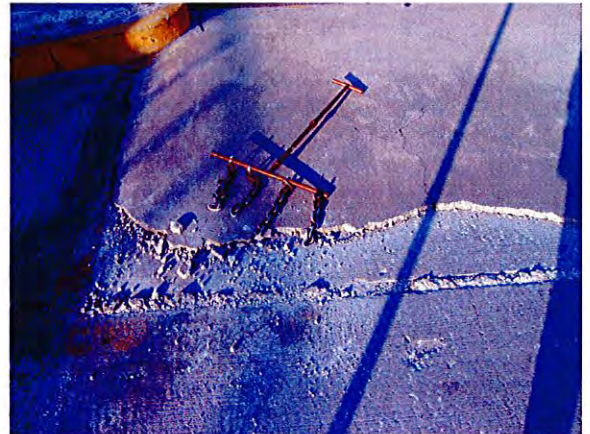
DEBONDED TOPPING

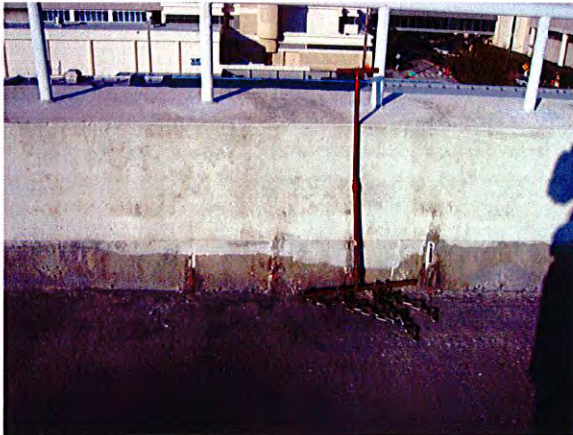
**PERIMETER BEAM DETERIORATION**

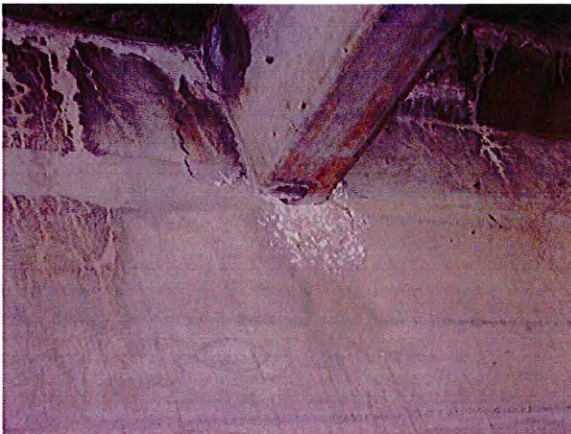
**THROUGH-SLAB LEAKAGE**

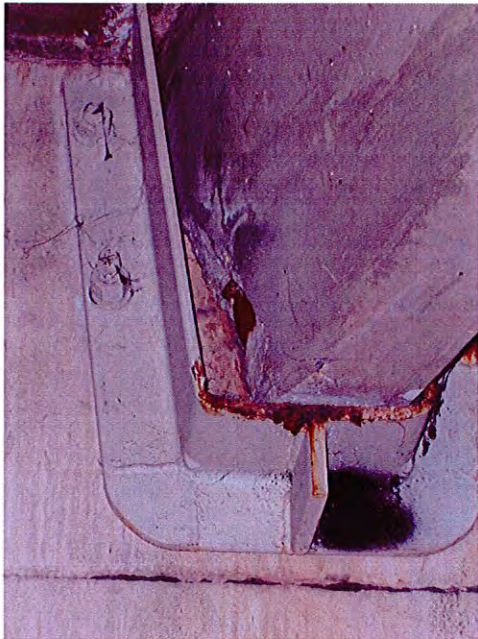
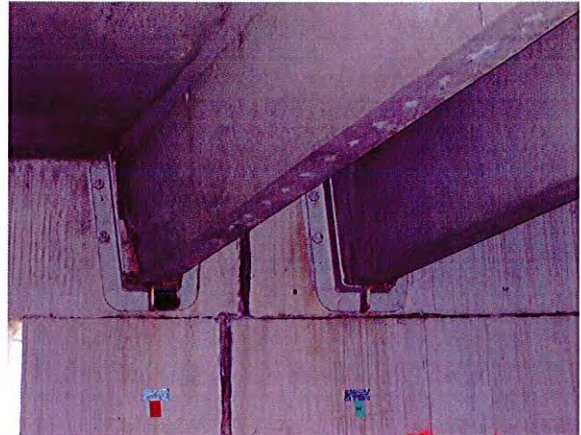
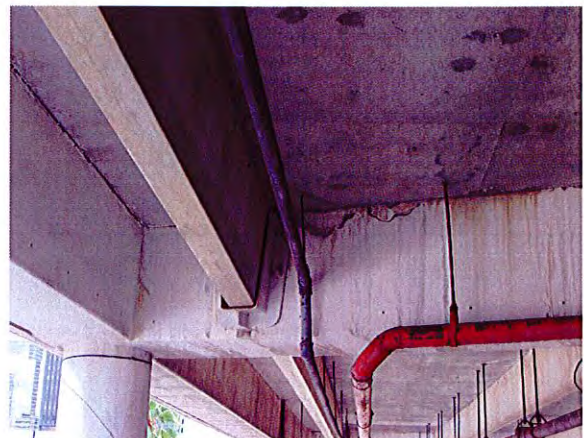
**STEEL COLLARS AND CONCRETE SPALLING AT CAZALY HANGERS**

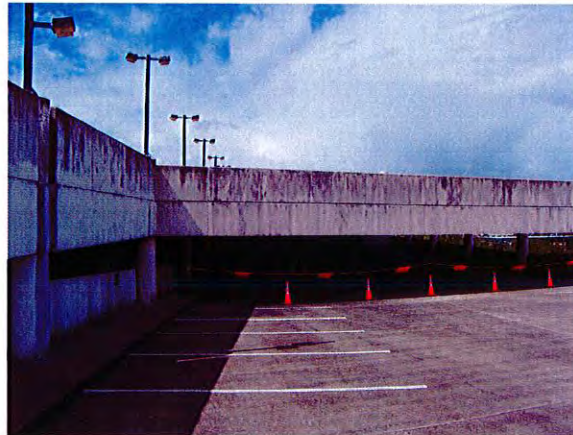
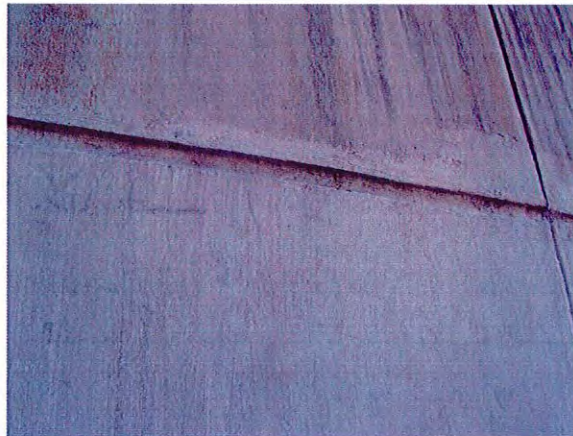
**FAÇADE STAINING**

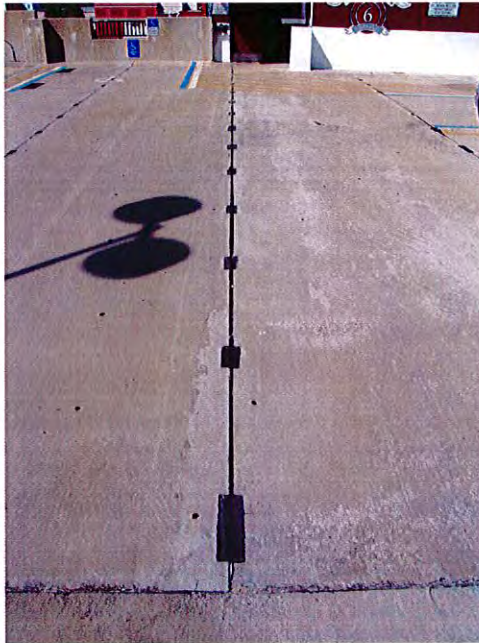
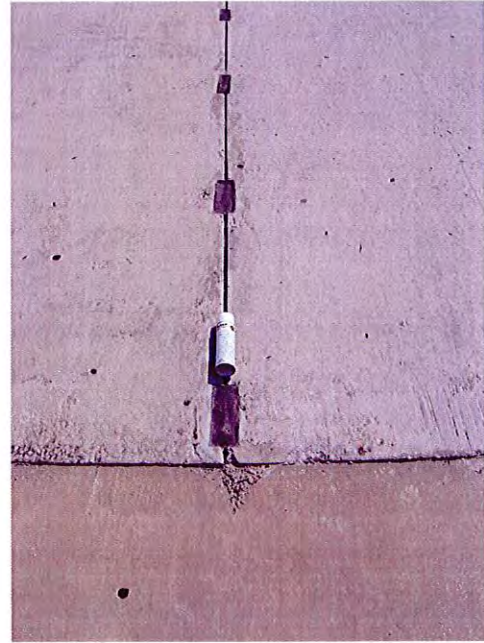
**TEE-TEE CONNECTIONS AT PRE-TOPPED TEES**

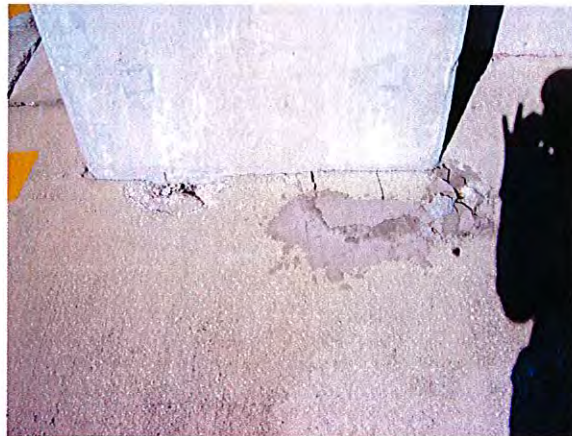
**SPALLED FLOOR SLAB CONNECTIONS AT COLUMNS  
AND SHEAR WALLS**

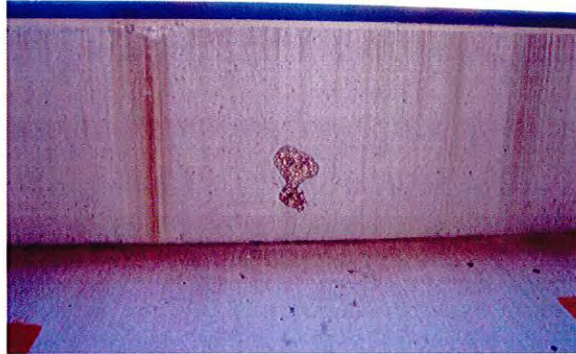
**MINOR SPALLING AT CONCRETE WALLS AND FLOOR SURFACES**

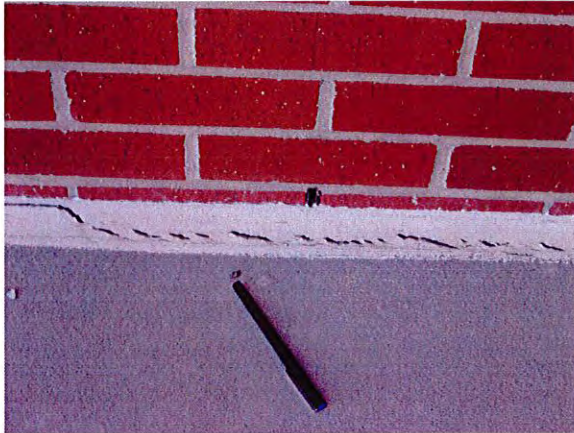
**SEALANT FAILURE AT FACADE JOINTS, FLOORS, AND CURBS**

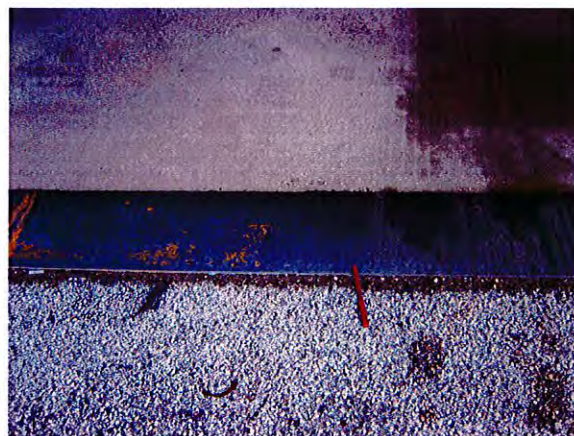
**EXPANSION JOINT DETERIORATION**

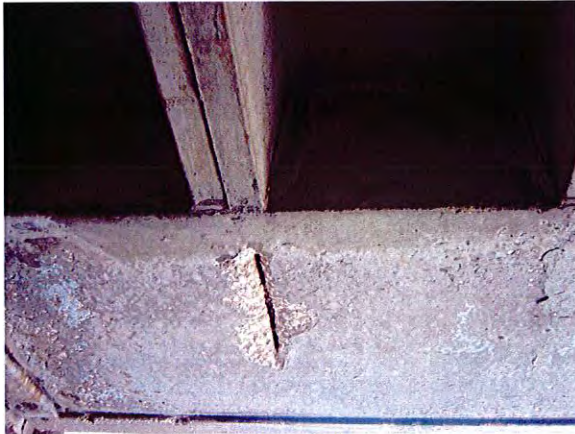
BEAM SOFFIT

**SHALLOW CONCRETE SPALLING**

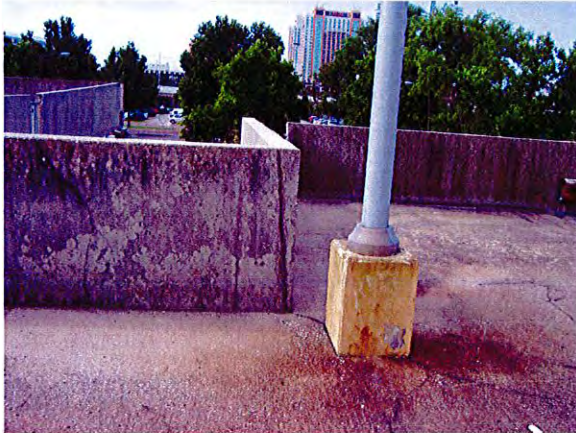
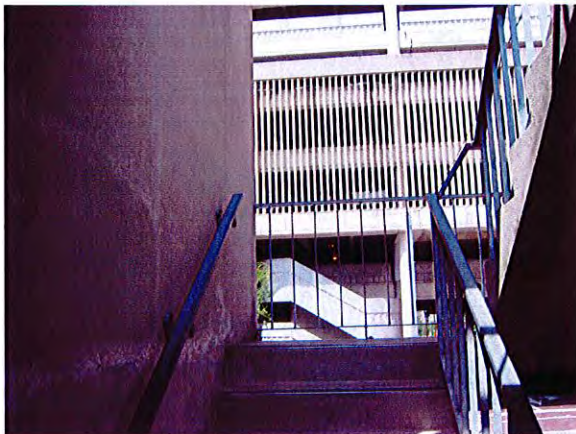
**LOW BARRIER WALL / RAILING CONDITIONS**
